Review Report

# Capsize of the racing yacht, *Nexba*

23 July 2023

## The Royal Prince Alfred Yacht Club

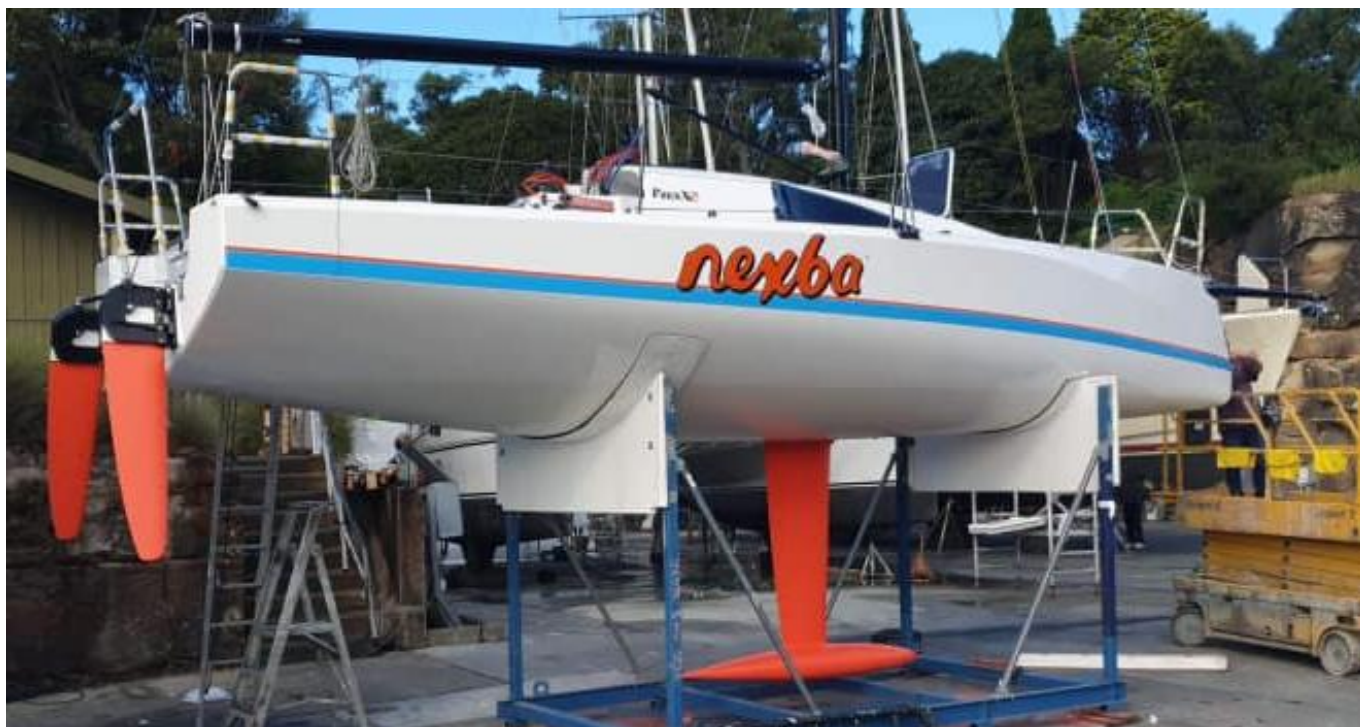
*Figure 1 High visibility appendages (rudders and keel) [Source: Skipper]*

4.7.1 The capsized yacht was not recognised from a large ship (assumed to be *Arietta Lily* by the sailors) or the rescue helicopter, both of which were seen by the sailors. The high-visibility colour of the underwater appendages (keel and rudders) can be seen in Figure 1. Whilst the keel colour became irrelevant after its loss, the rudders were still attached but not upright by daybreak when the sailors tried to gain the attention of a nearby ship. By 13:39 the visibility in the area was less than 2 nm in a ship's report, and by the time of the rescue, these rudders were missing. Review of World Sailing's, *2020-2021 Offshore Special Regulations: Governing Offshore Racing for Monohulls & Multihulls* [16] shows highly visible areas of pink, orange or yellow are required for multihulls (Category 1) when the boat is inverted.

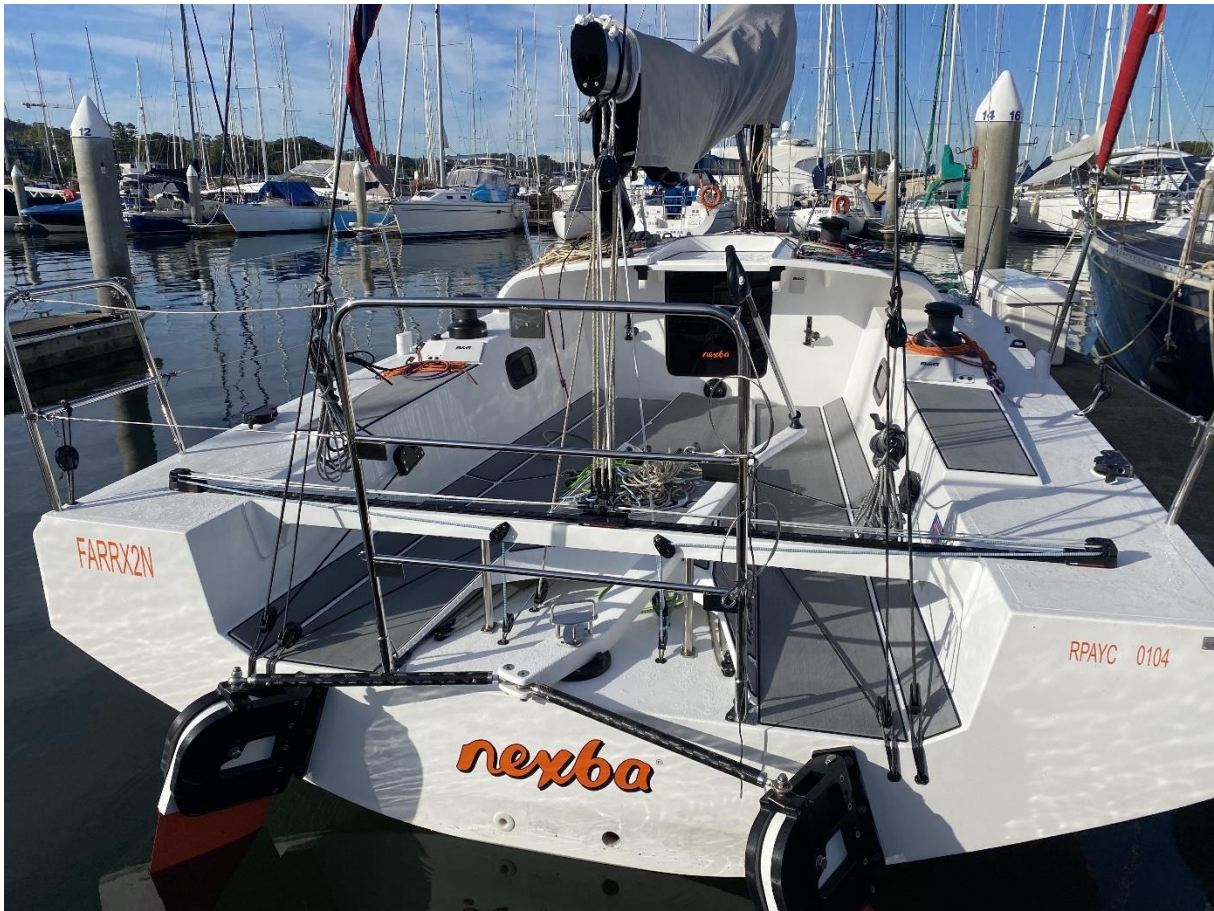
Figure 2 Nexba cockpit [Source: Sailors]

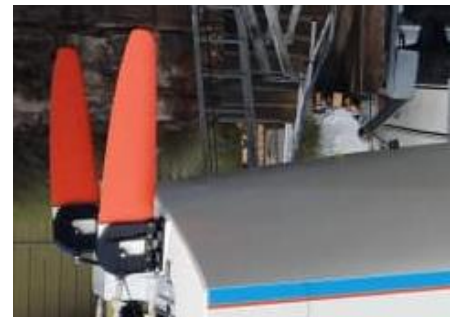
*Figure 4 Rudders shown in inverted orientation*

4.4.6 The sailors themselves noted their high risk of breaking legs with the movement of rudders, and the way they locked on with feet. They also noted the high risk of entanglement when tied to a rope while diving under the boat. Diving was not risked until the chances of rescue were viewed as slim by the sailors. The difficulties in having enough air, swimming while fatigued and in sea boots led to unsuccessful attempts.

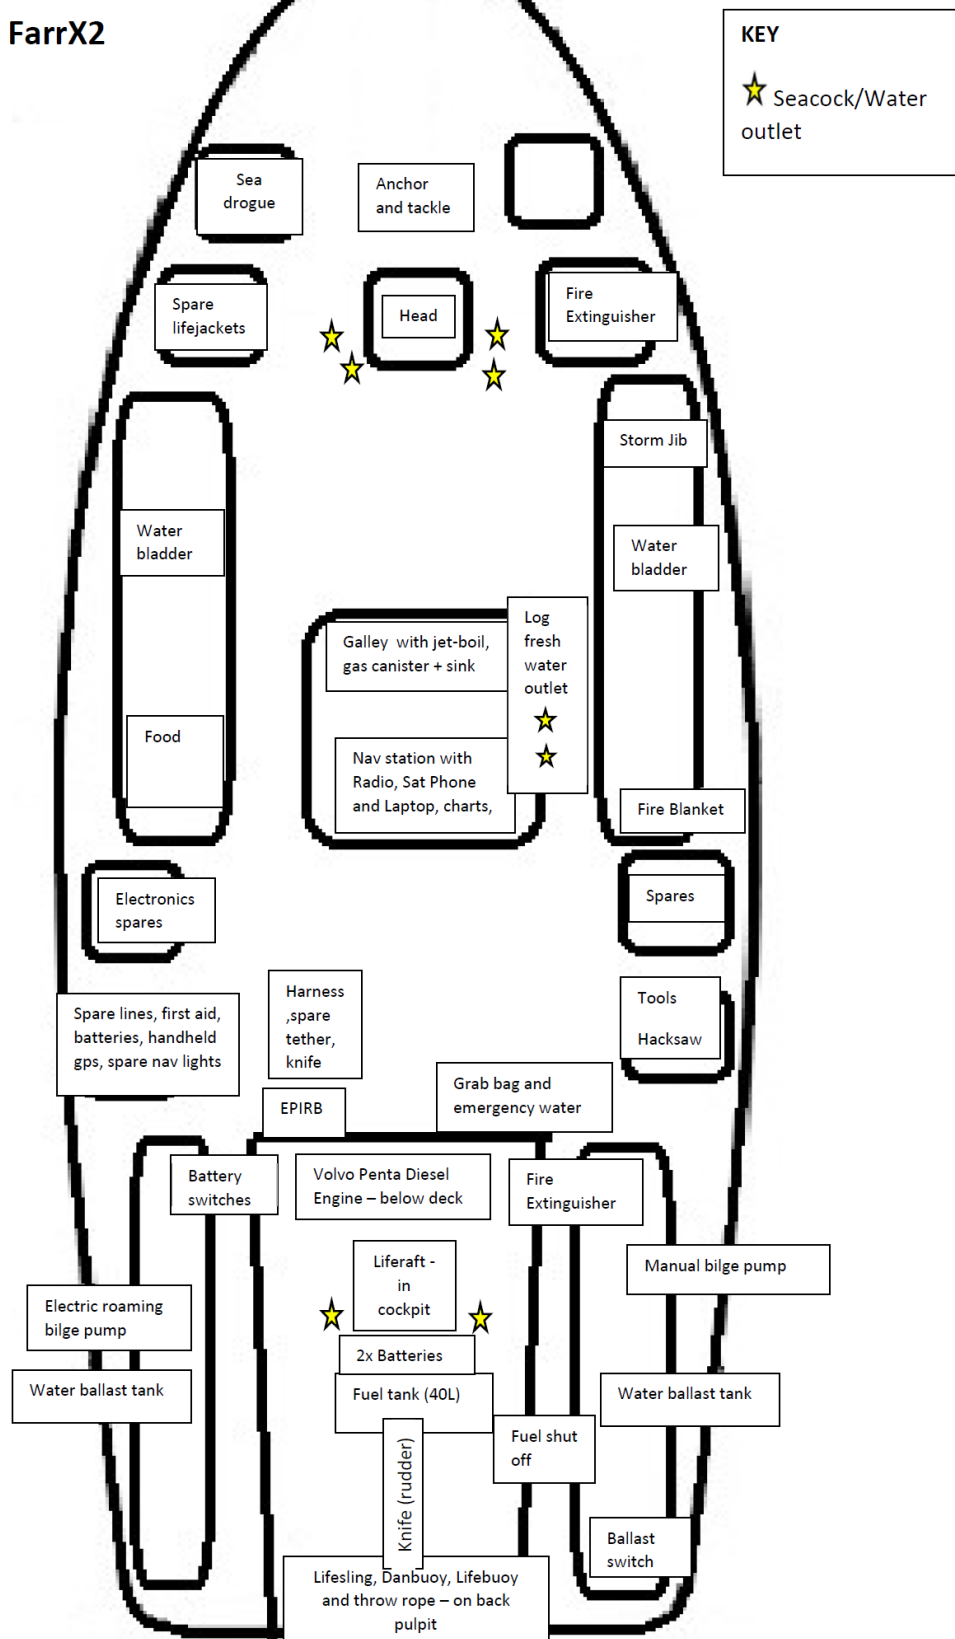
4.8.5 Despite the suitable location of the EPIRB beside the companionway, disorientation caused by the inversion of the boat made quick-release of the EPIRB or grab bag difficult.

Figure 5 - Nexba Stowage Chart [Source: Sailors]
