Review Report

# Capsize of the racing yacht, *Nexba*

23 July 2023

## The Royal Prince Alfred Yacht Club

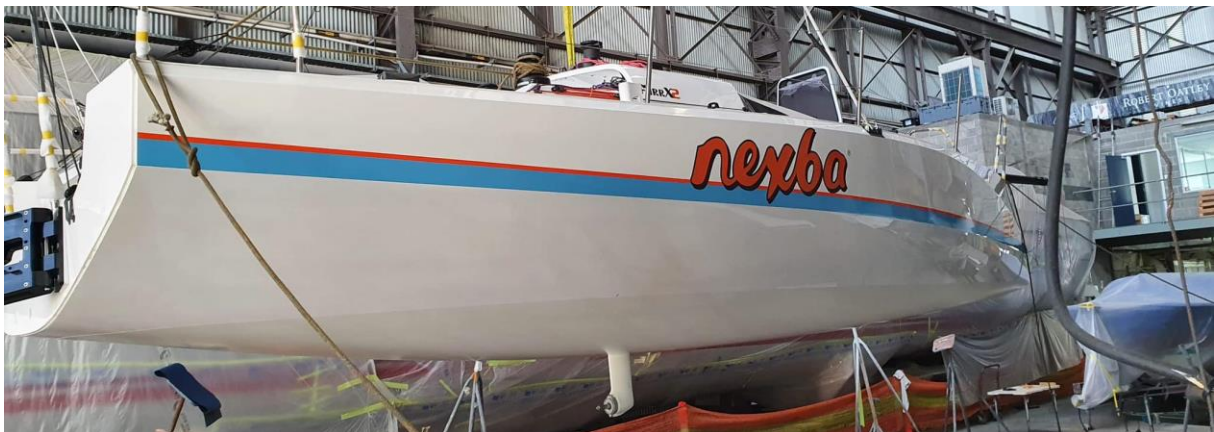
Figure 3 Nexba hull showing sail drive (propeller location) [4]

- 3.4.7 By about 11:00, after many hours near the transom, in worsening conditions the sailors became fatigued. They decided to make greater efforts to move to the hull high point at the folding propeller. In a break in the weather, the co-skipper was able to run up onto the hull, with a push from the skipper, and tied onto the sail drive. The skipper soon followed with the assistance of the rope. The co-skipper sat nearest the propeller (seen in Figure 3), with the skipper huddled around for warmth and protection.
